## **TRIAL PIT TEST**

## **LAND PARCEL NO. 3**

## **NAMLY AVENUE**

Client/Owner : Singapore Land Authority  
Conducted by : Seng & Keng Construction Pte Ltd  
Inspected & Certified : Millenniums Consultants  
Date : 05 June 2008

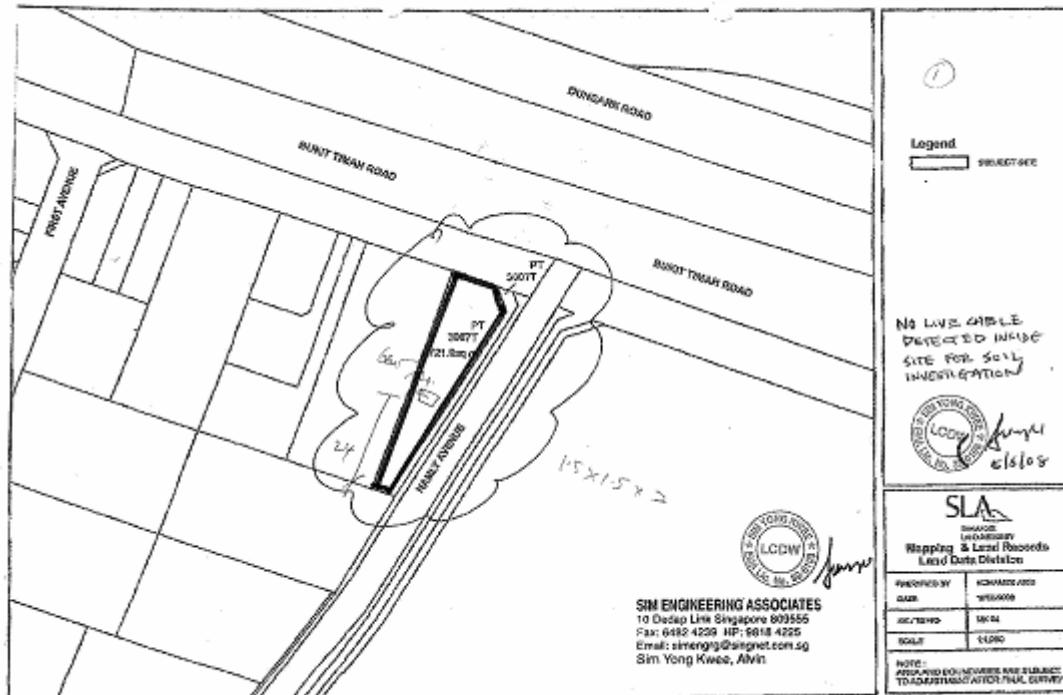
Namly Avenue Lot 3007T MK 04.

NO LIVE WIRE  
 DETECTED INSIDE  
 SITE FOR SOIL  
 INVESTIGATION

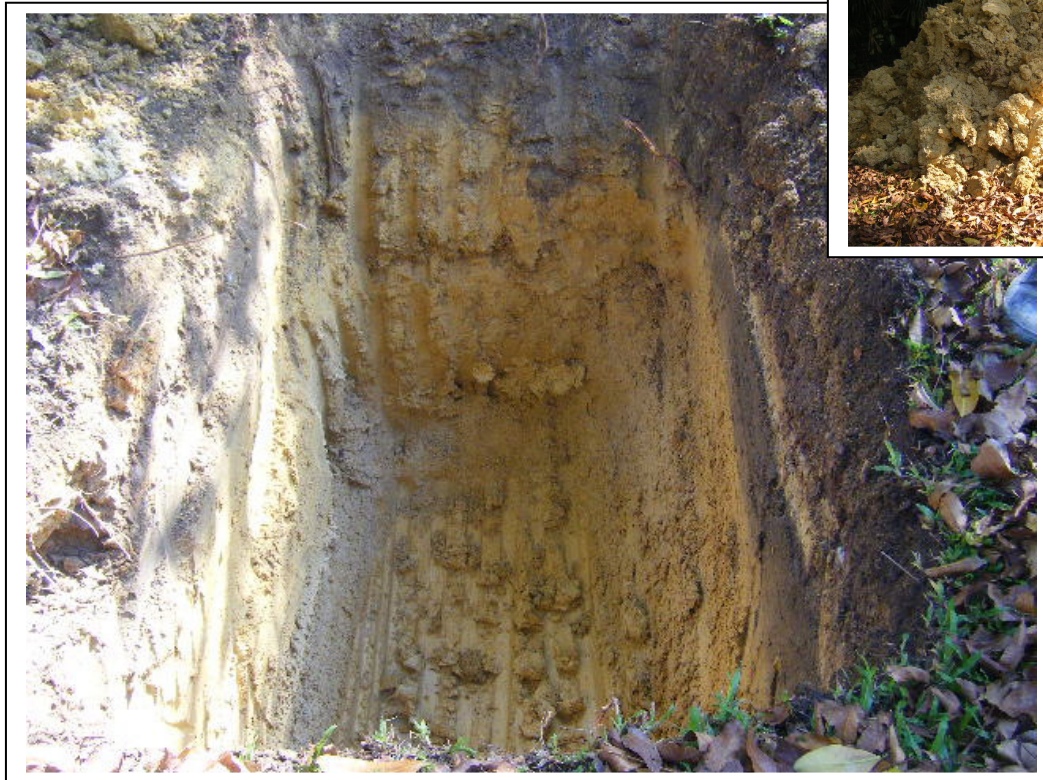
Location:	Land Parcel No. 3 at Namly Avenue
Trial Pit No:	001
Size:	1.5m length x 1.5m width x 3m depth
Original State:	Land with maintained cow grass turfing
Soil Condition up to 3 metres:	<p>The following materials were not found:</p> <ul style="list-style-type: none"><li>• marine clays</li><li>• peaty clays</li><li>• material from sump</li><li>• large timber pieces</li><li>• tree trunks</li><li>• rubber tyres</li><li>• materials susceptible to spontaneous combustion</li><li>• organic municipal waste</li><li>• other industrial and domestic refuse</li><li>• soil of liquid limit exceeding 70 and/or plasticity index exceeding 35</li><li>• materials having moisture content greater than the maximum permitted for such materials in the Contract, unless otherwise permitted by the Superintending Officer</li><li>• rock, which are hard material whose geological nature is to be regarded as such and individual boulders exceeding 0.20m<sup>3</sup> or other masses of hard natural material which necessitates the use of blasting or approved pneumatic tools for their removal.</li></ul>

Water Table:	No sign of water table

At the only trial pit that we have inspected, we found no signs of illegal dumping and water table. The soil condition is good.
