## **TRIAL PIT TEST**

## **LAND PARCEL NO. 3**

## **NAMLY AVENUE**

Client/Owner : Singapore Land Authority  
Conducted by : Seng & Keng Construction Pte Ltd  
Inspected & Certified : Millenniums Consultants  
Date : 05 June 2008

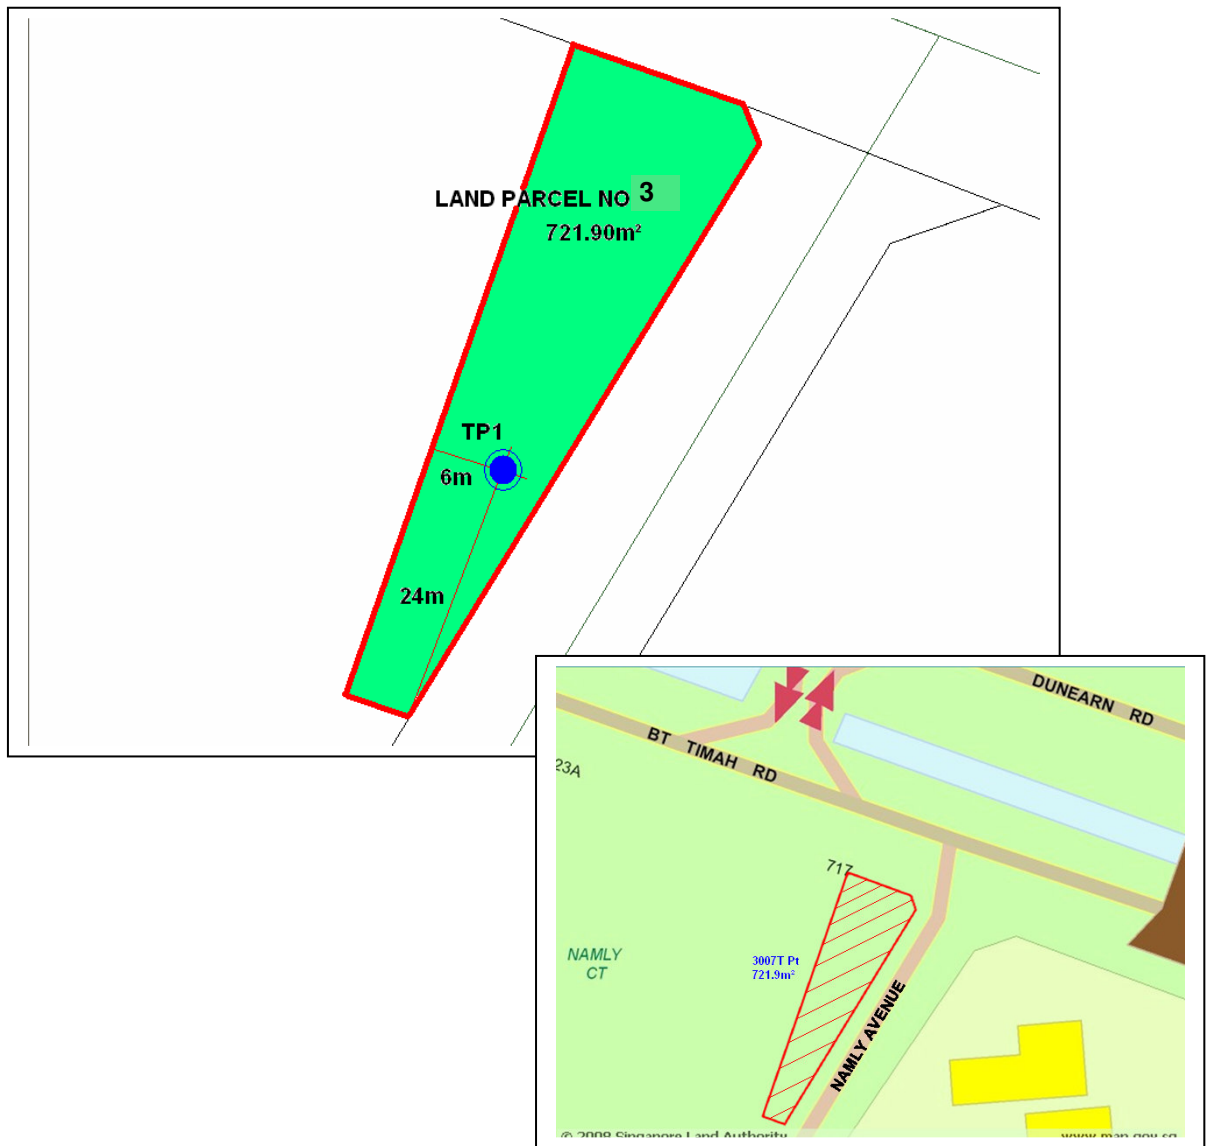
### 3 TRIAL PIT LOCATION PLAN

A total of 1 trial pit was excavated for approx. 721.90m<sup>2</sup> of land at location shown in the Trial Pit Location Plan (as attached). Prior to the excavation, cable detection has been carried out to confirm location of the services as this is a built up area.
